Fatigue assessment and retrofitting of Vilvoorde viaduct in Belgium

Marco Lucio Cerquaglia, Charles Havelange, Julien Buttino, Yves Duchene, Jean-Yves Del Forno

Bureau d'études Greisch, Allée des noisetiers 25, 4031 Liège

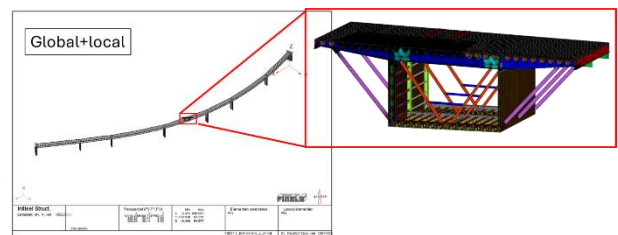
Figure 4: Global+local FE model

Although transversal behaviour of the bridge deck is mainly governed by local effects, longitudinal stresses result from both local and global effects. To correctly account for all the possible contributions to the stress field a global and local model are superposed (cf. Figure 4). Both models are realized with FINELG, Greisch in-house finite element (FE) solver, developed in collaboration

with the University of Liège. The global model is a beam model representing the whole viaduct. Concerning fatigue traffic loads, four different convoys must be considered at the global level (cf. Figure 5). These configurations must be evaluated for each truck type applied on the local model (see further).

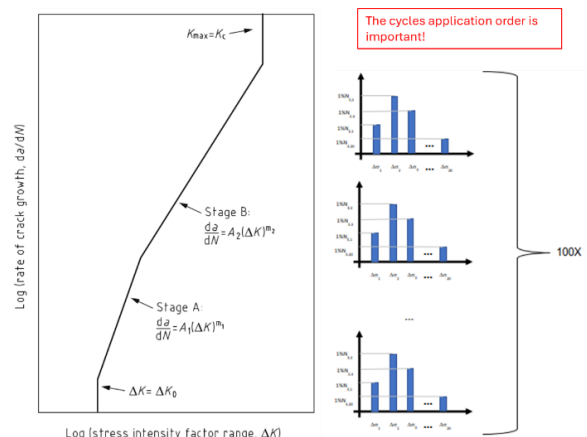
Figure 9: Double-slope Paris law and stress histograms used for crack propagation

This law establishes that crack size variation with respect to the number of cycles, N , is proportional to the stress intensity factor variation, $\Delta K(a)$, to the power m , where C and m are two constant material-dependent parameters. An example of double-slope Paris law, as proposed in [4] and employed in this project, is given in Figure 9.

To mimic the fact that in reality there is an alternance of different stress levels along time, the total histogram is subdivided into 100 sub-histograms which are subsequently applied to compute crack propagation. Each sub-histogram is thus representative of ~6 months of traffic (see Figure 9).
